COMMON CAUSES OF LEAKS

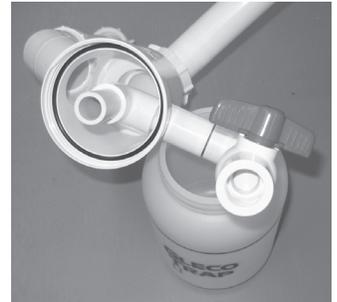
Properly seated O-Ring

1. The O-Ring is out of place or crimped.
 - Make sure it's seated in the channel provided.
 - If you are installing a brand-new O-Ring, give it a quick tug to stretch it slightly and dab a little petroleum jelly on it (or into the channel) before installing - it will fit into the channel a lot easier.

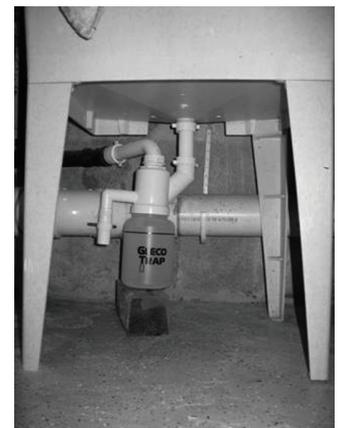
9. Bad connections to the sink drain or the wall waste line can cause leaks. In the example above, the waste line shows a light raise after The Gleco Trap, where it should be parallel to the floor.

Misaligned installation

6. Check the valve - you might not have gotten it completely shut.
7. Install The Gleco Trap so it hangs plumb. Don't cut corners on checking this part when installing The Gleco Trap. If it doesn't hang straight down, the weight of the bottle when it's hanging at a slight angle can prevent a good seal with the O-Ring as well as creating added pressure on the threads of the bottle. See the picture marked "misaligned installation" for an example. Notice how the slight angle led the customer to believe that support (the wooden block under the Gleco Trap) was needed? This installation also leads into our next problem.

8. If you have a utility sink, make sure that it's secured to the wall or floor so it doesn't move (which caused The Gleco Trap to hang at a slight angle in the example above). Even if you've taken the time to make sure it hangs plumb on installation, a bump of the sink when it's unsecured could pop the seals on your connections to The Gleco Trap and create a leak.
